# Parking Lot Condition Assessment

Bonavista Estates II — Lake Bonavista, Calgary

Prepared May 2026 • Confidential — For Condo Board Use Only

## 1211 Lake Fraser Green SE

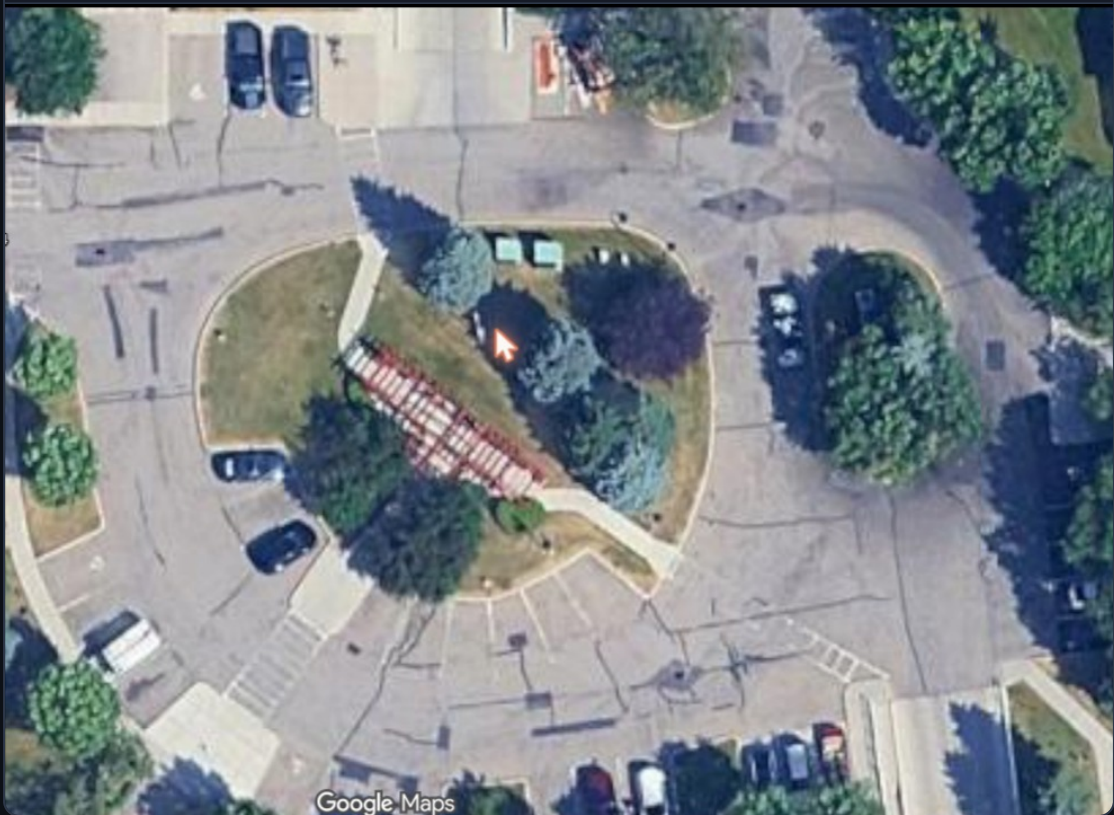
CENTRAL PARKING COURT — Main Lot, Circular Drive Lane & Resident Stalls

- **Surface oxidation:** Heavy graying and binder loss throughout the central court, drive lanes, and both entry approaches — consistent with 22-year-old unprotected asphalt in an Alberta climate.
- **Cracking:** Longitudinal and transverse cracks visible across the central court surface. Crack penetration has likely reached the

base course in high-traffic zones along the circular drive lane.

- **Line markings:** Stall markings severely faded throughout the central court. Directional arrows and crosswalk markings partially visible but significantly degraded — full re-stripe required.
- **Entry approaches:** Both the Lake Aspen Road SE and Lake Fraser Drive SE entries show surface oxidation and wear consistent with the main lot. Entry lanes are functional but show the same age-related distress.
- **Accessible parking:** Accessible stall markings require repainting to maintain compliance.
- **Drainage:** The circular court low-point and curved drive lanes are prone to ponding — standing water at this stage of pavement life accelerates sub-base deterioration.

**Full crack fill, clean & seal coat, and complete re-stripe.** At 22 years with visible cracking and binder loss across all areas, this surface is at the last viable window for cost-effective preservation. Sealing now extends service life 8-12 years. Deferring 2-3 more

seasons risks base course damage requiring mill-and-repave at 3-5× the cost.
