# Parking Lot Condition Assessment

Bonavista Estates II — Lake Bonavista, Calgary

Prepared May 2026 • Confidential — For Condo Board Use Only

## 1211 Lake Fraser Green SE

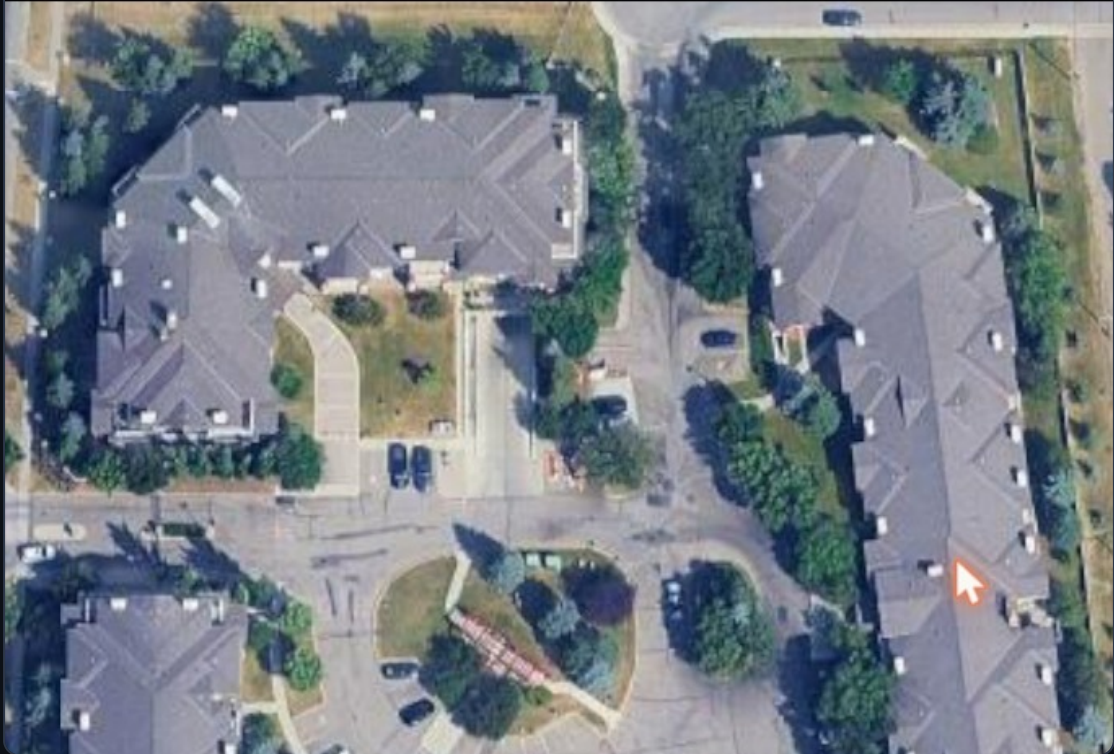
AERIAL OVERVIEW — Full Complex, 1211 Lake Fraser Green SE

- **Surface oxidation:** Heavy graying and binder loss throughout the central court, drive lanes, and both entry approaches — consistent with 22-year-old unprotected asphalt in an Alberta climate.
- **Cracking:** Longitudinal and transverse cracks visible across the central court surface. Crack penetration has likely reached the

base course in high-traffic zones along the circular drive lane.

- **Line markings:** Stall markings severely faded throughout the central court. Directional arrows and crosswalk markings partially visible but significantly degraded — full re-stripe required.
- **Entry approaches:** Both the Lake Aspen Road SE and Lake Fraser Drive SE entries show surface oxidation and wear consistent with the main lot. Entry lanes are functional but show the same age-related distress.
- **Accessible parking:** Accessible stall markings require repainting to maintain compliance.
- **Drainage:** The circular court low-point and curved drive lanes are prone to ponding — standing water at this stage of pavement life accelerates sub-base deterioration.

**Full crack fill, clean & seal coat, and complete re-stripe.** At 22 years with visible cracking and binder loss across all areas, this surface is at the last viable window for cost-effective preservation. Sealing now extends service life 8-12 years. Deferring 2-3 more

seasons risks base course damage requiring mill-and-repave at 3-5× the cost.
